ASTBURY HYDRAULIC LIME WORKS, NEWBOLD, CHESHIRE.

Len Kirkham

Abstract: A Lower Carboniferous inlier of high quality limestone outcrops unconformably against Triassic sandstones and Keuper Marl to the west, and Lower Minns Sandstone and ganisters to the east. The limestone was both quarried as well as mined at depth from early times. No other such mineral existed within an economic distance of early transport. Recent access was gained into the main level by clearing a blockage in a shaft, down to a long-lost 560-yard pony-level or adit. This paper records our findings underground, with a brief outline of the history.

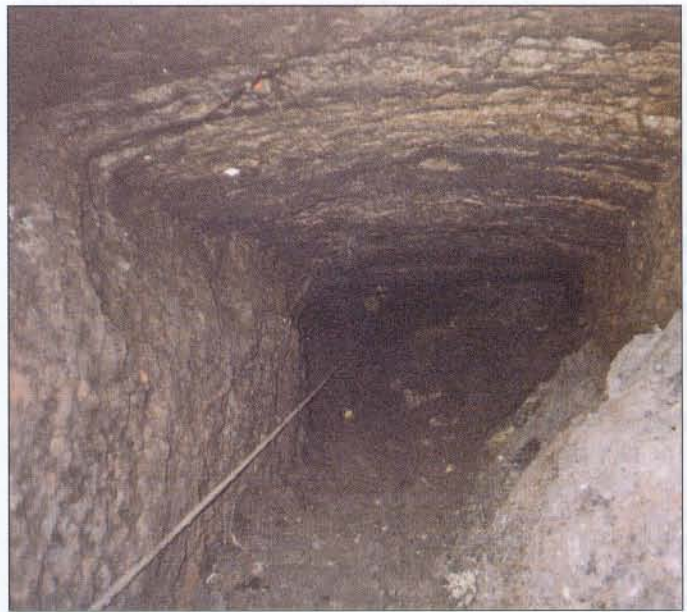
Plate 2. The level during pumping via the adit.

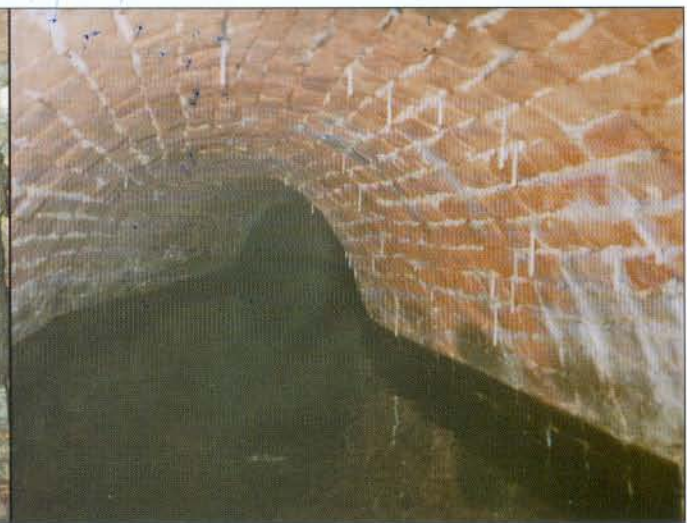
Plate 4. Near the end of the horse-drawing level just before the fall.

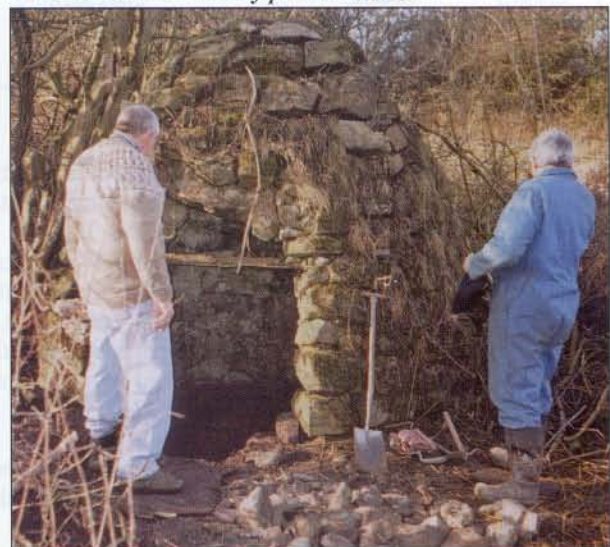
Plate 6. The 18th century powder house.

Tangible evidence is still to be seen of the scale of working. The three shafts on the pony level, the special kilns in the old rail sidings are as when last fired, and amazingly a beehive gunpowder magazine of the 18th century has survived intact. An attempt to get it listed has been made but without response.
